**Flood Control Project Maintenance**  
**2012 Structure Summary Report**  
**Overall Unit and Item Ratings**

## San Joaquin County Flood Control and Water Conservation District

### Duck Creek Diversion Weir And Control Structure

**Flood Control Project Maintenance****Unit Cover Sheet****2012 Structure Inspection Results****San Joaquin County Flood Control and Water Conservation District**

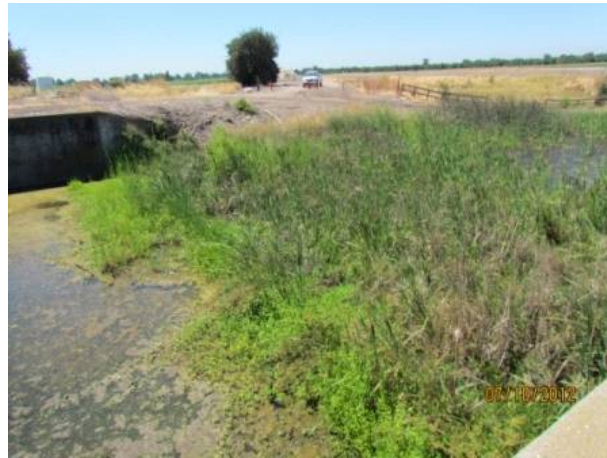
Levee Mile Report Line	1
Start Levee Mile	0.00
End Levee Mile	0.00
Location	
Category	Structures
Item	Vegetation & Obstructions

LMR No.	Levee Mile		Category	Item	Location	Rating	Action/Comment	GPS Latitude/Longitude		Issue No.
	Start	End						Start	End	Photo
1	0.00	0.00	Structures	Vegetation & Obstructions		A	Inspector Comments: There was minimal vegetation around the structure. The flow was not impeded.	37.938383 ° -120.990133 °	37.938383 ° -120.990133 °	2 Y
2	0.00	0.00	Structures	Shoaling / Sedimentation		A	Inspector Comments: No shoaling or sediment was present.	37.938383 ° -120.990133 °	37.938383 ° -120.990133 °	3
3	0.00	0.00	Structures	Erosion / Bank Caving		A	Inspector Comments: No erosion or bank caving was observed on the side of the levee.	37.938383 ° -120.990133 °	37.938383 ° -120.990133 °	4
4	0.00	0.00	Structures	Revetments		A	Inspector Comments: Existing riprap protection was properly maintained.	37.938383 ° -120.990133 °	37.938383 ° -120.990133 °	5 Y
5	0.00	0.00	Structures	Encroachments		A	Inspector Comments: No trash or debris was found around the structure.	37.938383 ° -120.990133 °	37.938383 ° -120.990133 °	6

View of the vegetation at the control structure.

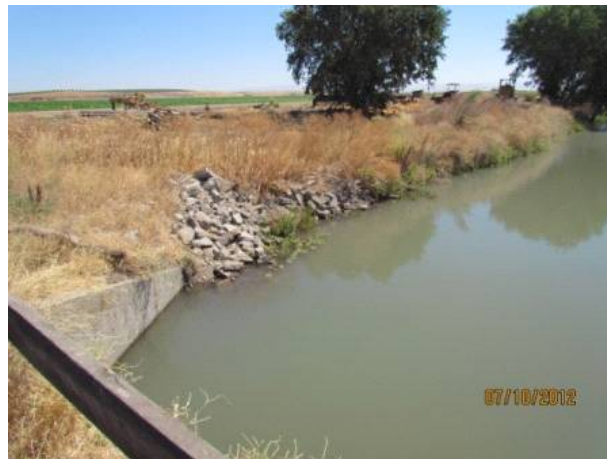
Levee Mile Report Line	4
Start Levee Mile	0.00
End Levee Mile	0.00
Location	
Category	Structures
Item	Revetments

View of the revetments looking upstream.

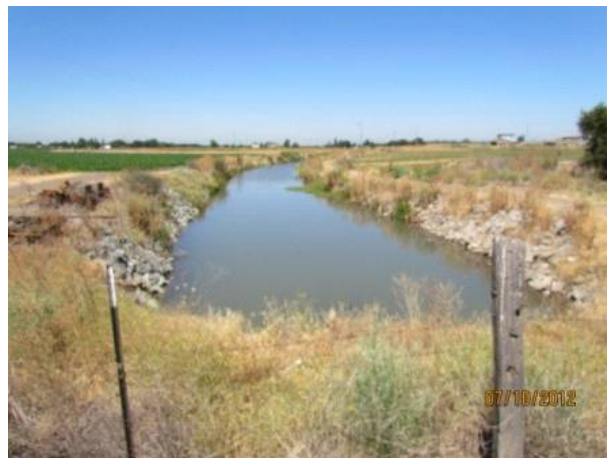
Levee Mile Report Line	4
Start Levee Mile	0.00
End Levee Mile	0.00
Location	
Category	Structures
Item	Revetments

View of the revetments looking downstream.

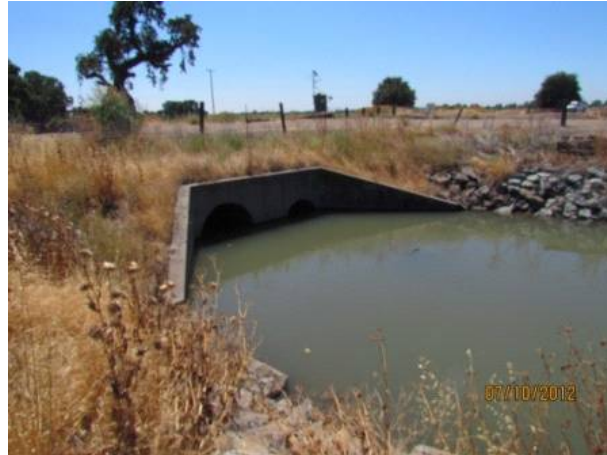
6	0.00	0.00	Structures	Culverts: Inlets / Outlets		A	Inspector Comments: The culvert's inlet and outlet were free of any debris.	37.938383 ° -120.990133 °	37.938383 ° -120.990133 °	7 Y
7	0.00	0.00	Structures	Culverts: Breaks / Holes / Cracks		A	Inspector Comments: No visible cracks or holes were found that would result in significant water leakage in the culvert.	37.938383 ° -120.990133 °	37.938383 ° -120.990133 °	8
8	0.00	0.00	Structures	Metal Pipes		A	Inspector Comments: The corrugated pipes inside the culvert appeared to be in good condition.	37.938383 ° -120.990133 °	37.938383 ° -120.990133 °	9
9	0.00	0.00	Structures	Trash Racks		N	Inspector Comments: This item does not apply to this inspection.	37.938383 ° -120.990133 °	37.938383 ° -120.990133 °	10
10	0.00	0.00	Structures	Flap Gates		N	Inspector Comments: No flap gates were present at this structure.	37.938383 ° -120.990133 °	37.938383 ° -120.990133 °	11

Levee Mile Report Line	6
Start Levee Mile	0.00
End Levee Mile	0.00
Location	
Category	Structures
Item	Culverts: Inlets / Outlets
View of the culvert outlet.	
pkazi_t_20120810_167.jpg

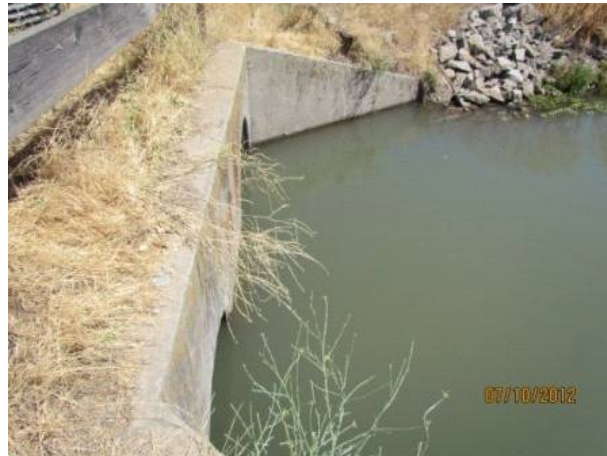
Levee Mile Report Line	6
Start Levee Mile	0.00
End Levee Mile	0.00
Location	
Category	Structures
Item	Culverts: Inlets / Outlets
View of the culvert inlet.	
pkazi_t_20120810_168.jpg

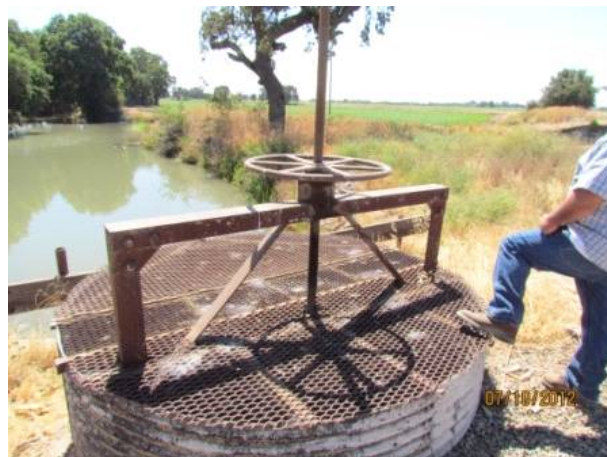
Levee Mile Report Line	13
Start Levee Mile	0.00
End Levee Mile	0.00
Location	
Category	Structures
Item	Manual Gate Operators
View of the manual gate.	
pkazi_t_20120810_169.jpg

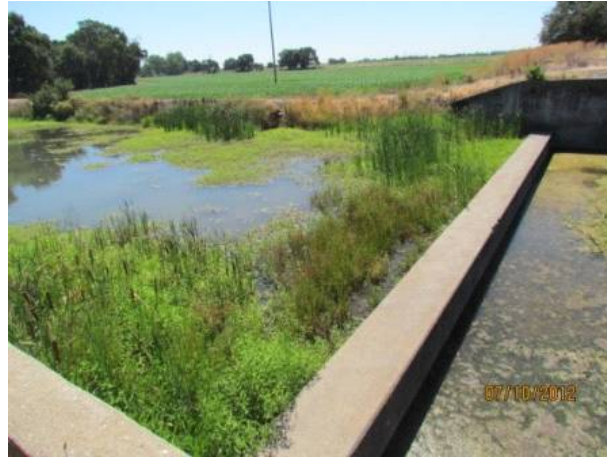
Levee Mile Report Line	14
Start Levee Mile	0.00
End Levee Mile	0.00
Location	
Category	Structures
Item	Concrete Surfaces

LMR No.	Levee Mile		Category	Item	Location *	Rating **	Action/Comment	GPS Latitude/Longitude		Issue No.
	Start	End						Start	End	Photo
14	0.00	0.00	Structures	Concrete Surfaces		A	Inspector Comments: The concrete surfaces had minor cracking and the surface was weathered but they didn't pose any threats to the integrity of the structure.	37.938383 ° -120.990133 °	37.938383 ° -120.990133 °	15 Y
15	0.00	0.00	Structures	Concrete Tilting / Settlement		A	Inspector Comments: No visible sliding or settlement was found on the structure.	37.938383 ° -120.990133 °	37.938383 ° -120.990133 °	16
16	0.00	0.00	Structures	Concrete Foundations		A	Inspector Comments: No souring or erosion was found near the structure.	37.938383 ° -120.990133 °	37.938383 ° -120.990133 °	17
17	0.00	0.00	Structures	Security Fencing		N	Inspector Comments: No security fence was found in this structure.	37.938383 ° -120.990133 °	37.938383 ° -120.990133 °	18

View of the weir.

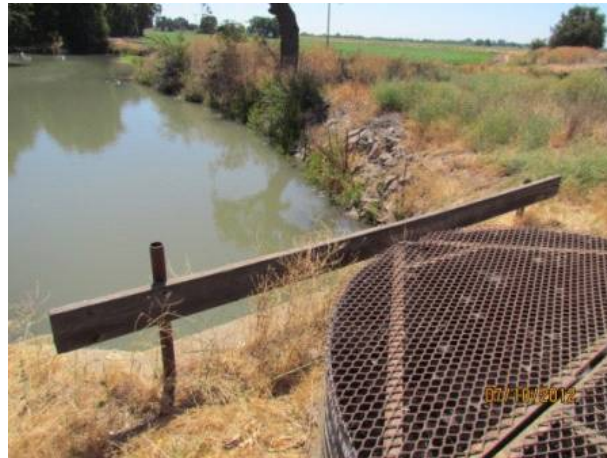
Levee Mile Report Line	22
Start Levee Mile	0.00
End Levee Mile	0.00
Location	
Category	Structures
Item	Safety

View of the railing top of the culvert.

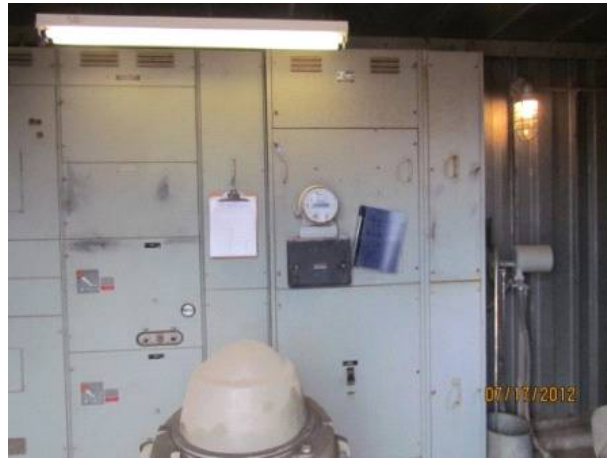
Levee Mile Report Line	1
Start Levee Mile	0.00
End Levee Mile	0.00
Location	
Category	Pump Stations
Item	Operating Log

View of the operation log in the plant.

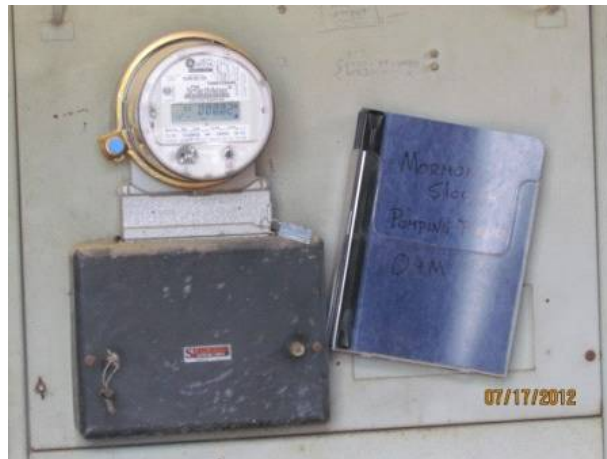
Levee Mile Report Line	2
Start Levee Mile	0.00
End Levee Mile	0.00
Location	
Category	Pump Stations
Item	Operation & Maintenance Manual

View of the O&M manual inside the plant.

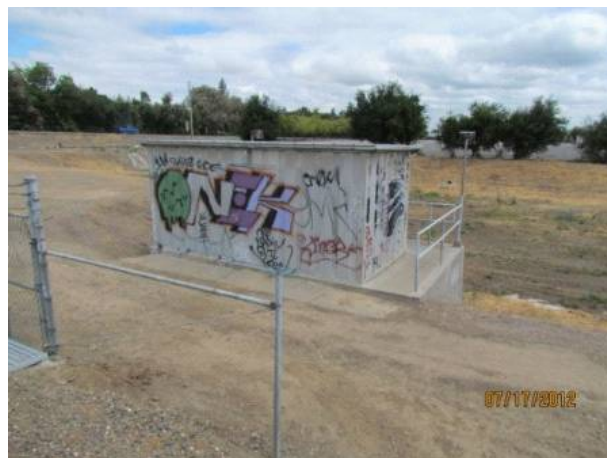
Levee Mile Report Line	3
Start Levee Mile	0.00
End Levee Mile	0.00
Location	
Category	Pump Stations
Item	Plant Building

View of the pumping plant.

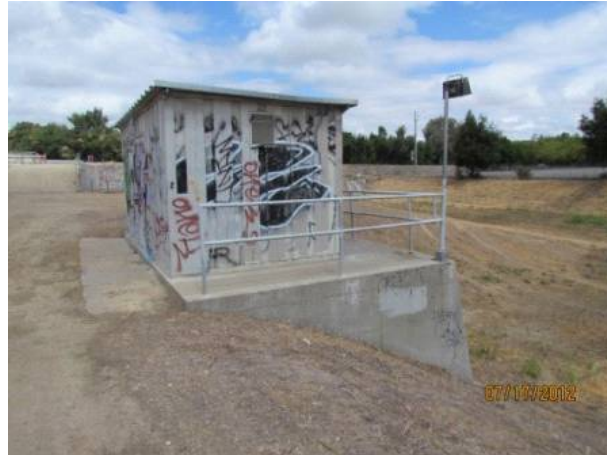
Levee Mile Report Line	5
Start Levee Mile	0.00
End Levee Mile	0.00
Location	
Category	Pump Stations
Item	Safety

View of the guard rails around the plant.

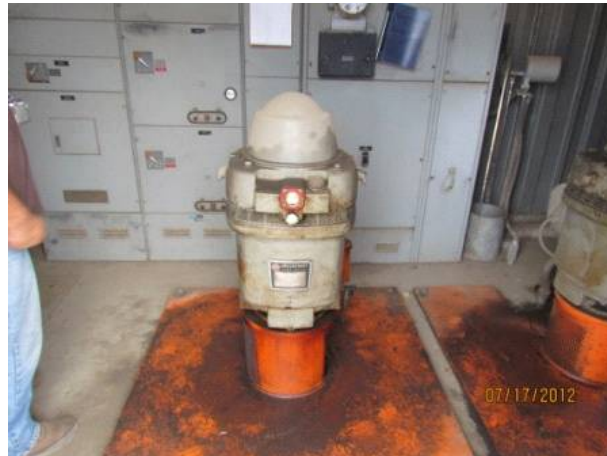
Levee Mile Report Line	7
Start Levee Mile	0.00
End Levee Mile	0.00
Location	
Category	Pump Stations
Item	Pumps

View of one of the pumps inside the plant.

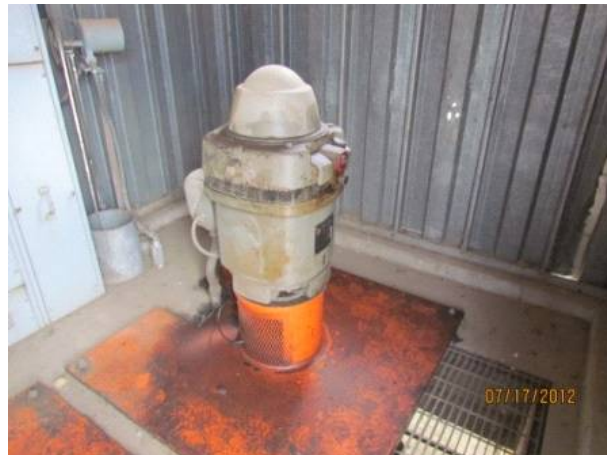
Levee Mile Report Line	7
Start Levee Mile	0.00
End Levee Mile	0.00
Location	
Category	Pump Stations
Item	Pumps

View of a pump inside the plant.

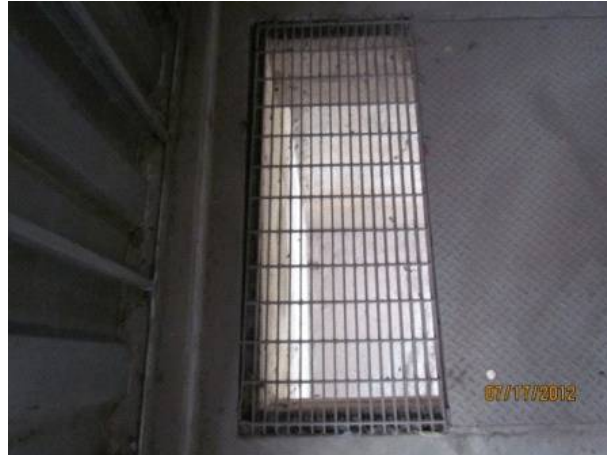
Levee Mile Report Line	11
Start Levee Mile	0.00
End Levee Mile	0.00
Location	
Category	Pump Stations
Item	Sumps/Wet Well

LMR No.	Levee Mile		Category	Item	Location *	Rating **	Action/Comment	GPS Latitude/Longitude		Issue No.
	Start	End						Start	End	Photo
11	0.00	0.00	Pump Stations	Sumps/Wet Well		A	Item inspected visually only. Item was not operated during the inspection. Inspector Comments: The wet well was completely dry and very little debris was present during inspection.	37.989633 ° -121.266933 °	37.989633 ° -121.266933 °	12 Y
12	0.00	0.00	Pump Stations	Trash Racks		A	Item inspected visually only. Item was not operated during the inspection. Inspector Comments: Trash racks were properly maintained and clear of debris.	37.989633 ° -121.266933 °	37.989633 ° -121.266933 °	13 Y
13	0.00	0.00	Pump Stations	Trash Rakes		N	Item inspected visually only. Item was not operated during the inspection. Inspector Comments: Trash rakes don't exist at this plant.	37.989633 ° -121.266933 °	37.989633 ° -121.266933 °	14
14	0.00	0.00	Pump Stations	Sluice / Slide Gates		A	Item inspected visually only. Item was not operated during the inspection. Inspector Comments: The slide gate appeared to be in good condition.	37.989633 ° -121.266933 °	37.989633 ° -121.266933 °	15 Y

View of the well which was completely dry.

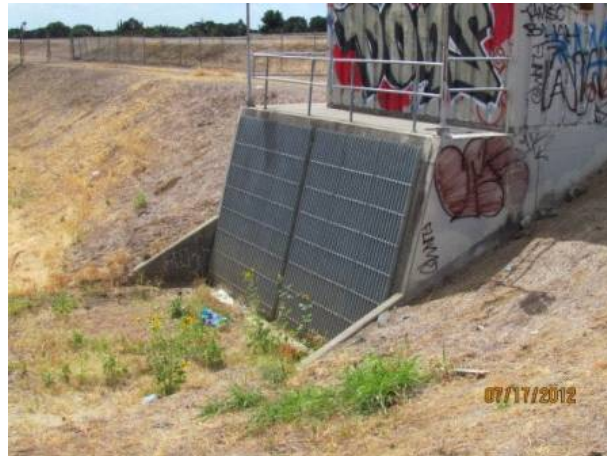
Levee Mile Report Line	12
Start Levee Mile	0.00
End Levee Mile	0.00
Location	
Category	Pump Stations
Item	Trash Racks

View of the trash racks.

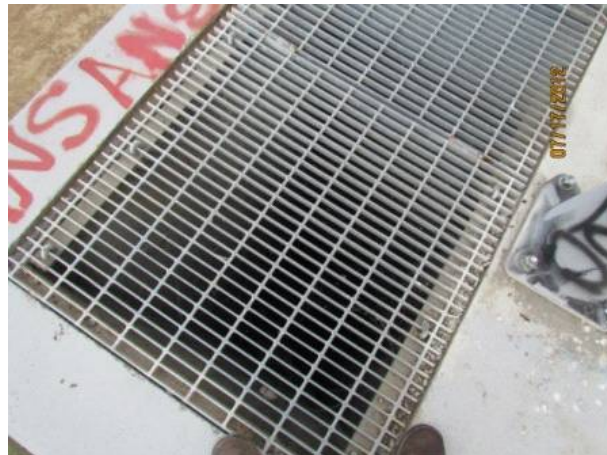
Levee Mile Report Line	14
Start Levee Mile	0.00
End Levee Mile	0.00
Location	
Category	Pump Stations
Item	Sluice / Slide Gates

View of the slide gate well. The bottom well was free of debris.

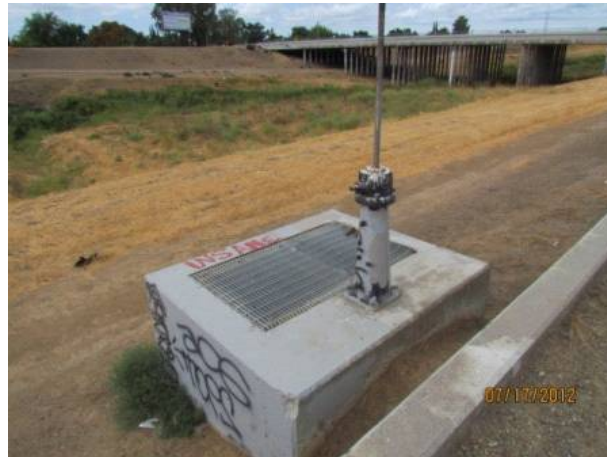
Levee Mile Report Line	16
Start Levee Mile	0.00
End Levee Mile	0.00
Location	
Category	Pump Stations
Item	Manual Gate Operators
View of the manual gate.	
pkazi_t_20120724_137.jpg

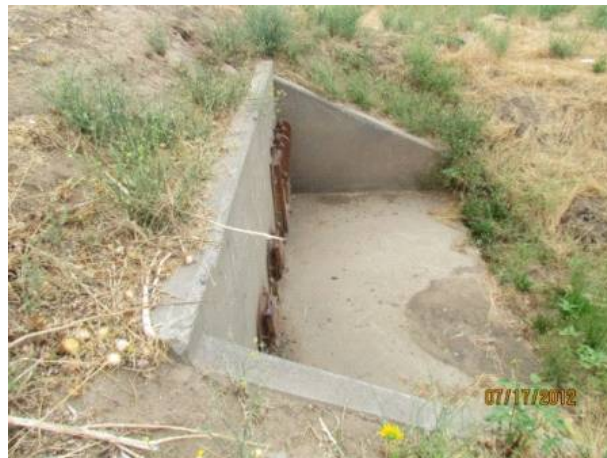
Levee Mile Report Line	18
Start Levee Mile	0.00
End Levee Mile	0.00
Location	
Category	Pump Stations
Item	Flap Gates
View of the flap gates.	
pkazi_t_20120724_138.jpg

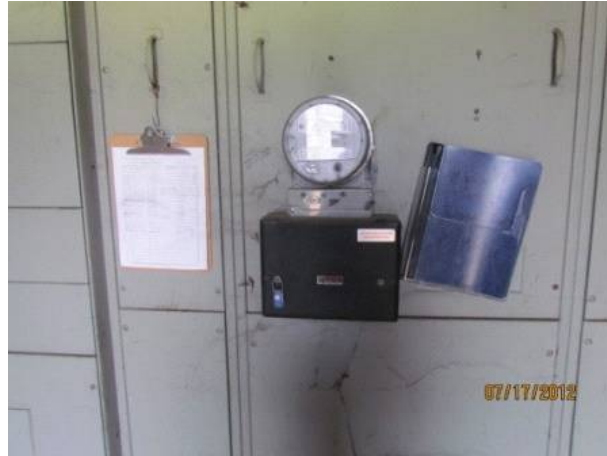
View of the operation log and O&M manual inside the pumping plant.

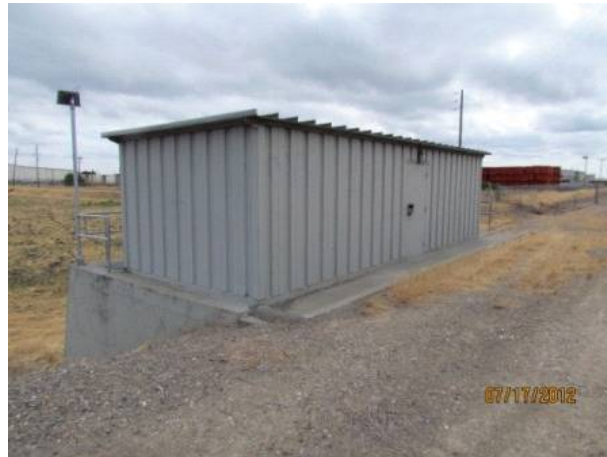
Levee Mile Report Line	3
Start Levee Mile	0.00
End Levee Mile	0.00
Location	
Category	Pump Stations
Item	Plant Building

View of the pumping plant.

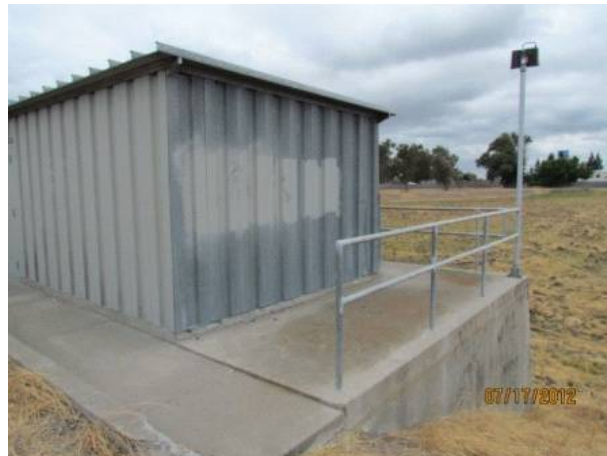
Levee Mile Report Line	5
Start Levee Mile	0.00
End Levee Mile	0.00
Location	
Category	Pump Stations
Item	Safety

View of the hand rails around the pumping plant.

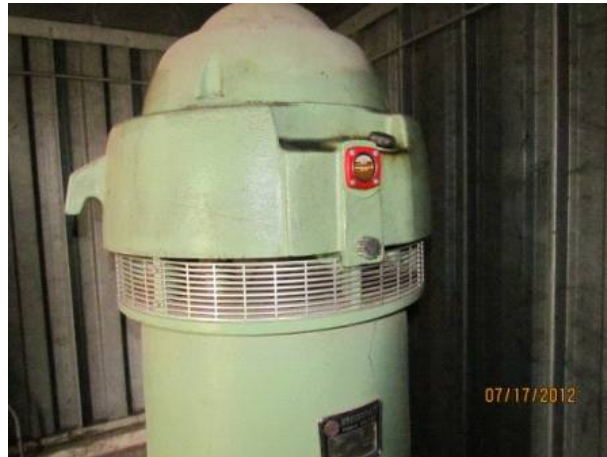
View of one of the pumps.

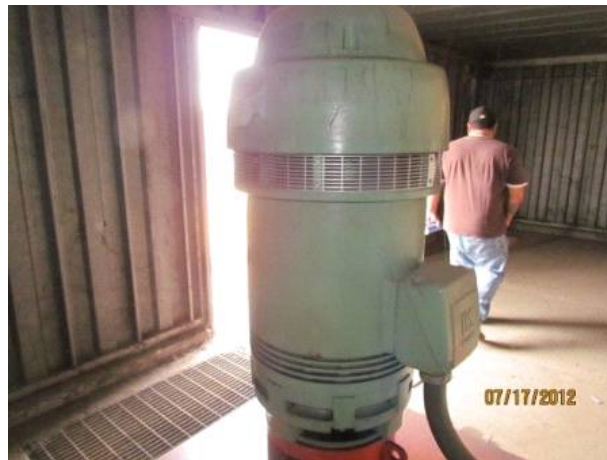
Levee Mile Report Line	7
Start Levee Mile	0.00
End Levee Mile	0.00
Location	
Category	Pump Stations
Item	Pumps

View of another pump.

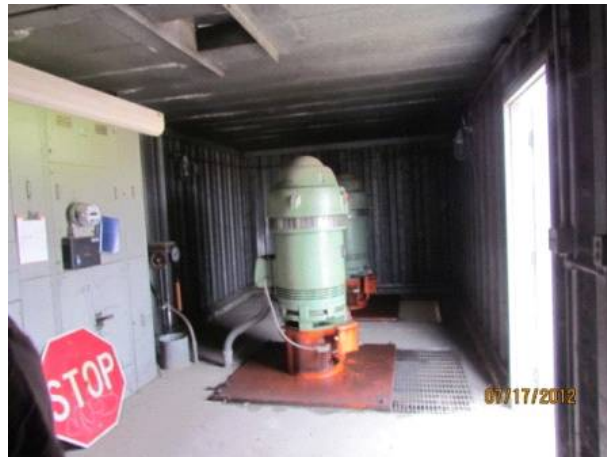
Levee Mile Report Line	10
Start Levee Mile	0.00
End Levee Mile	0.00
Location	
Category	Pump Stations
Item	Pump Control Systems

View of the power control system.

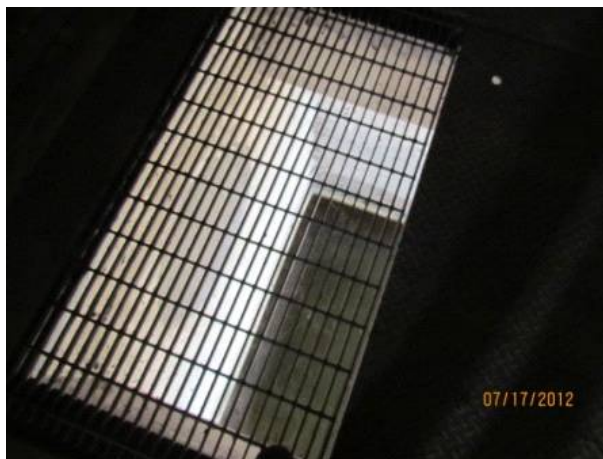
View of the wet well.

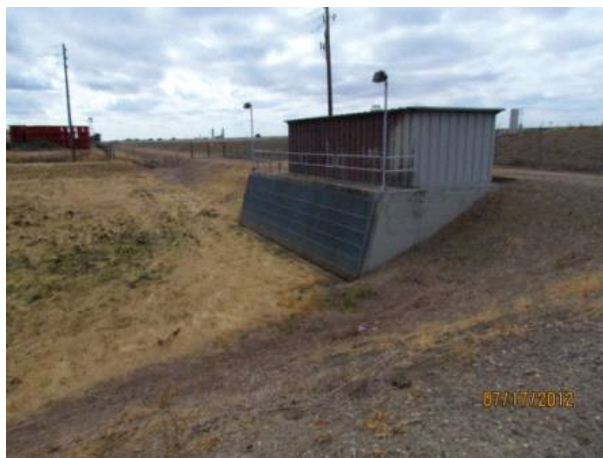
Levee Mile Report Line	12
Start Levee Mile	0.00
End Levee Mile	0.00
Location	
Category	Pump Stations
Item	Trash Racks

View of the trash racks.

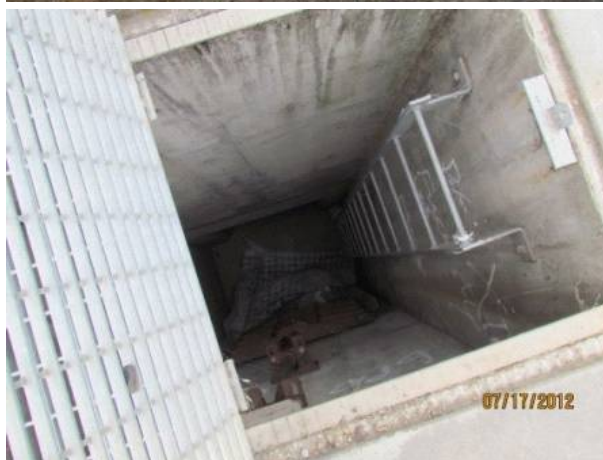
Levee Mile Report Line	14
Start Levee Mile	0.00
End Levee Mile	0.00
Location	
Category	Pump Stations
Item	Sluice / Slide Gates

View of encroachment bottom of the slide gate.

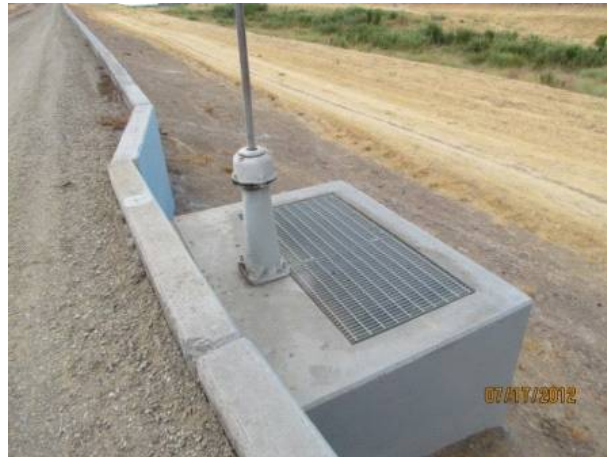
View of the manual gate.

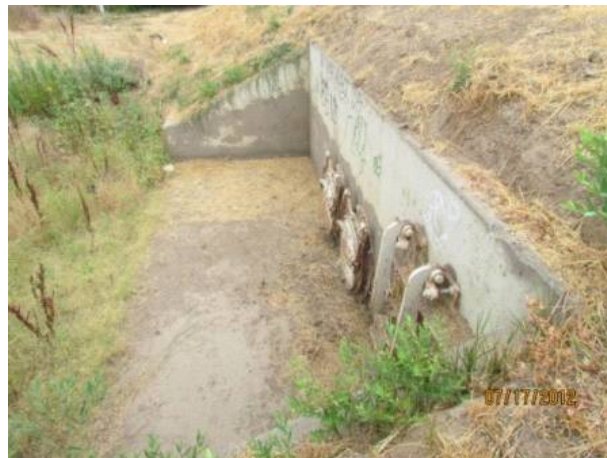
Levee Mile Report Line	18
Start Levee Mile	0.00
End Levee Mile	0.00
Location	
Category	Pump Stations
Item	Flap Gates

View of the flap gates on the waterside.

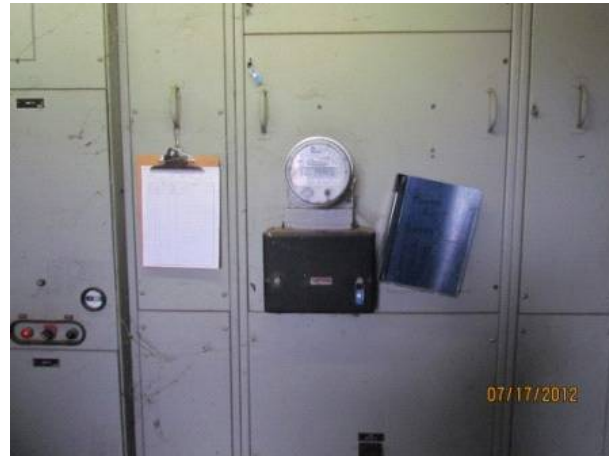
View of the operating log and O&M manual inside the pumping plant.

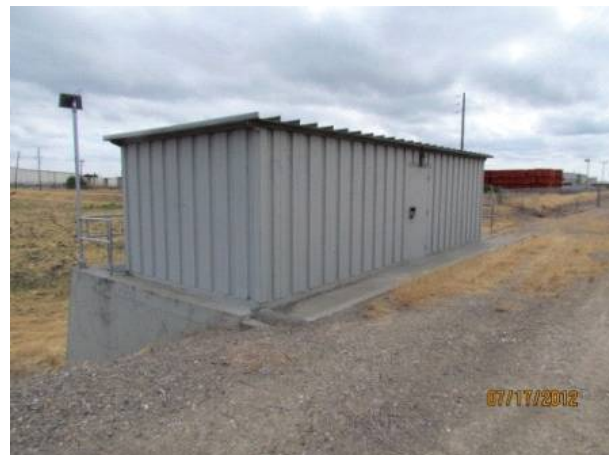
Levee Mile Report Line	5
Start Levee Mile	0.00
End Levee Mile	0.00
Location	
Category	Pump Stations
Item	Safety

View of the guard rails around the plant.

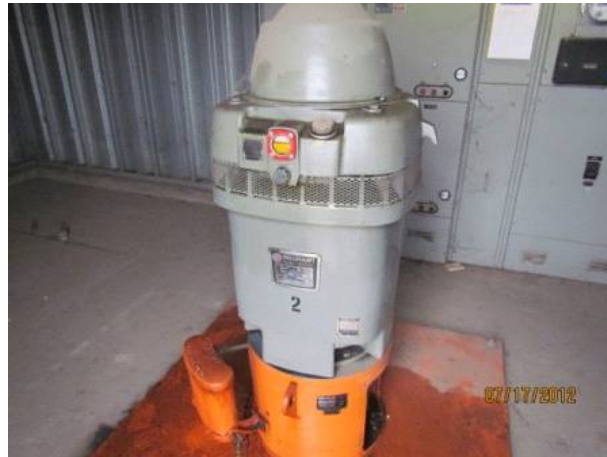
View of one of the pumps.

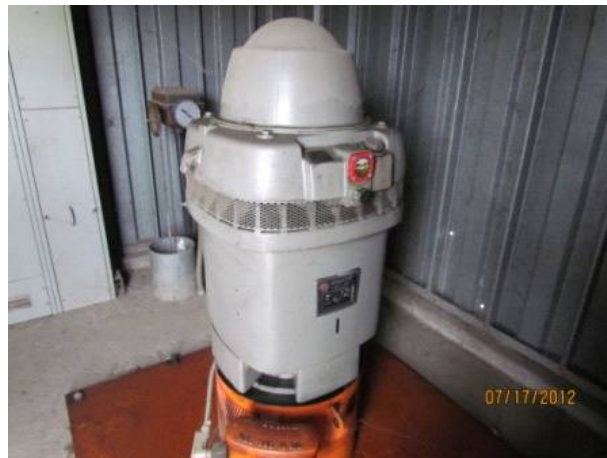
Levee Mile Report Line	7
Start Levee Mile	0.00
End Levee Mile	0.00
Location	
Category	Pump Stations
Item	Pumps

View of another pump inside the pumping plant.

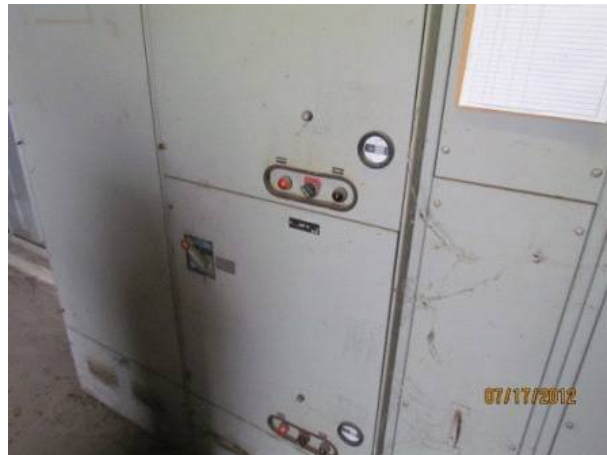
Levee Mile Report Line	10
Start Levee Mile	0.00
End Levee Mile	0.00
Location	
Category	Pump Stations
Item	Pump Control Systems

View of the power control systems inside the plant.

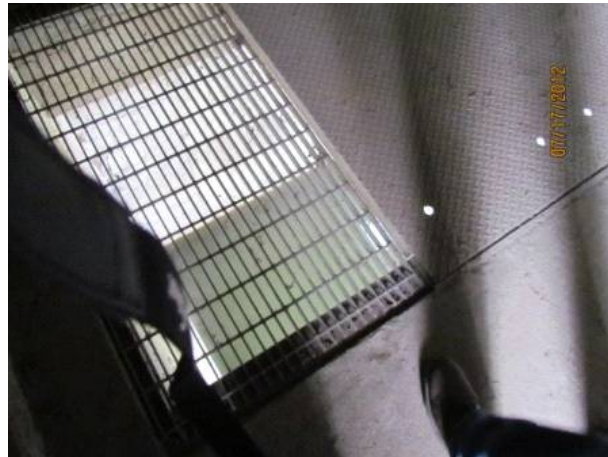
View of wet well.

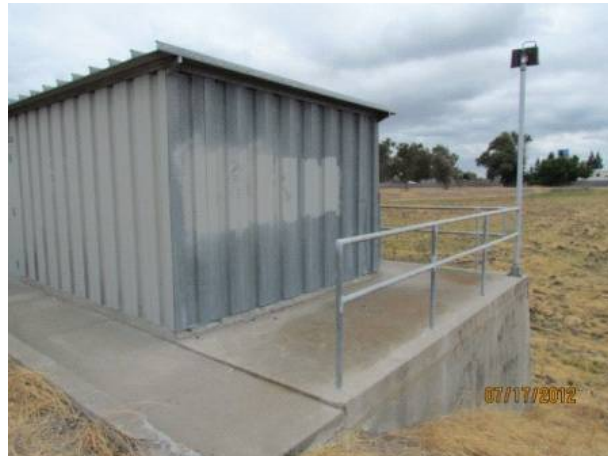
Levee Mile Report Line	12
Start Levee Mile	0.00
End Levee Mile	0.00
Location	
Category	Pump Stations
Item	Trash Racks

View of the trash racks.

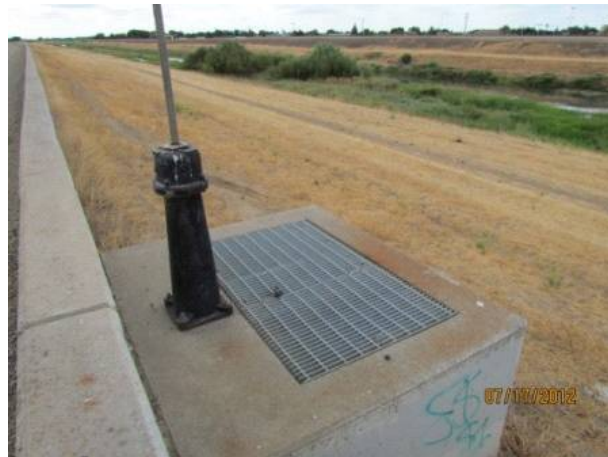
Levee Mile Report Line	14
Start Levee Mile	0.00
End Levee Mile	0.00
Location	
Category	Pump Stations
Item	Sluice / Slide Gates

View of the slide gate.

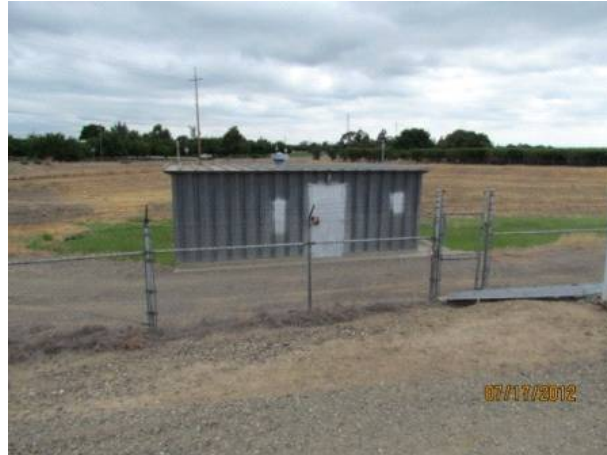
Levee Mile Report Line	20
Start Levee Mile	0.00
End Levee Mile	0.00
Location	
Category	Pump Stations
Item	Security Fencing
View of the security fencing around the pumping plant.	
pkazi_t_20120720_114.jpg
